FINAL REPORT

***Rapid Geohazard Assessment of Vulnerable Area of
Different parts of Nepal***

(Molung Rural Municipality, Ward no. 7, Okhaldhunga)

Manifold Consult Pvt. Ltd.
Banasthali, Kathmandu
Phone No: 9860816776

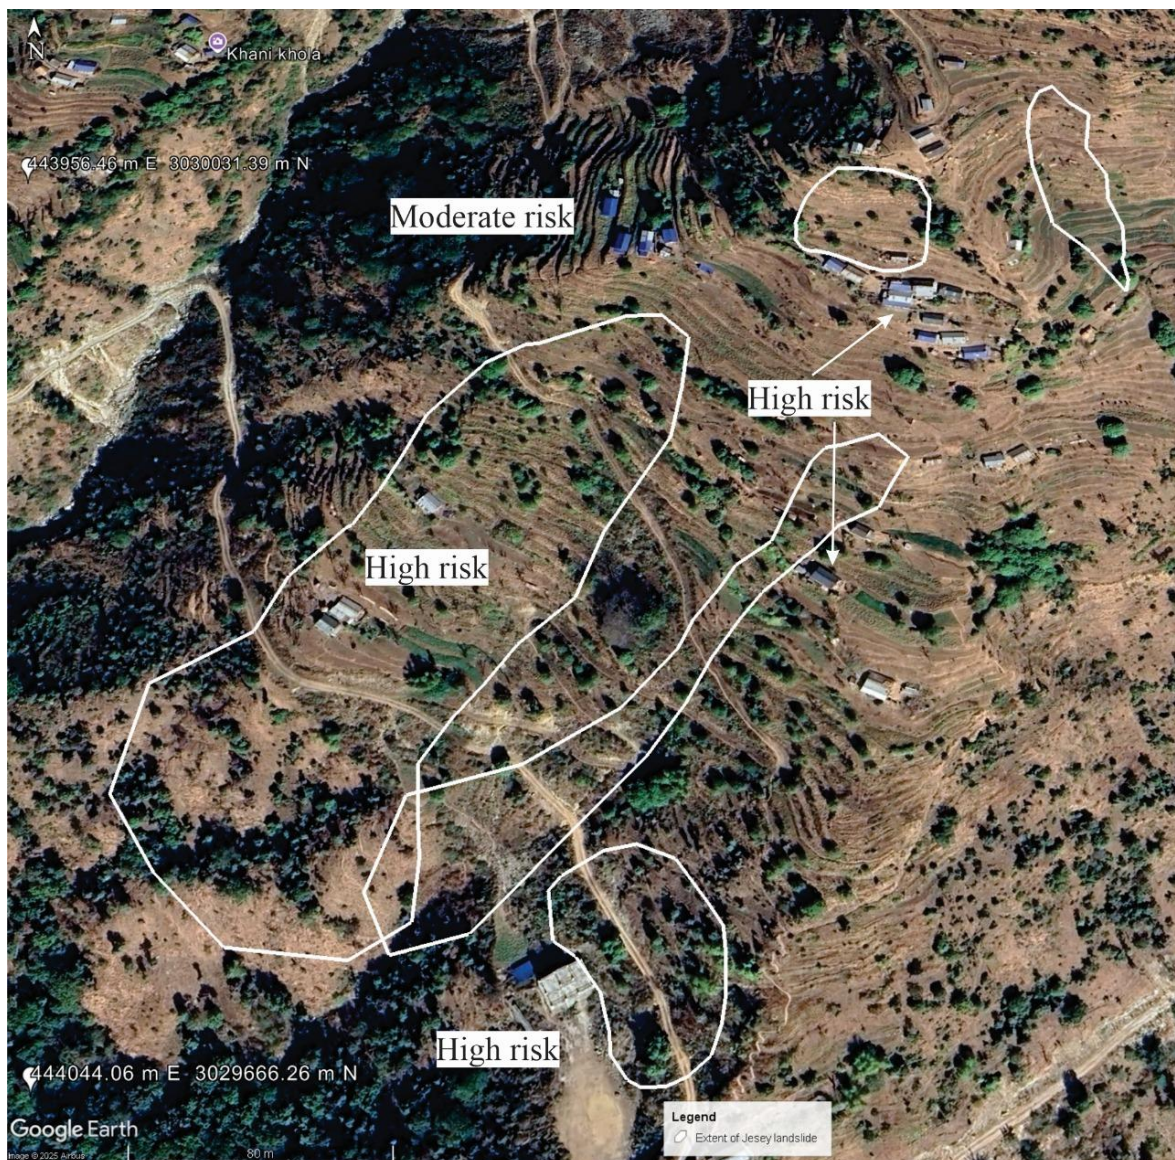
Figure 12: Google Earth image showing unstable landmass of the Jesey Landslide

The unstable mass is flowing towards 245°. The instability is present on concave as well as convex slope, with landslide active and still expanding. Gullies have been formed on the slope by surface runoff. As per the locals, numerous tension cracks were present in the landslide, most have been filled at present. The cracks ranged in length ~20-25 m, ~15 cm wide, and ~1 m deep.

The slope is composed of easily erodible debris material. Construction of roads on the slope removed the underlying support for the materials leading to instability. The surface runoff from top of the slope flows into the same landmass and settlements, which acted as trigger mechanism for initiation of debris flow.

As an immediate measure, the houses at high risk (Figure 12) should be relocated as the debris flow can be re-initiated even by slight rainfall and may affect the settlement.

The settlement present at Jesey Landslide area is recommended for relocation soon as possible as debris flow can be re-initiated even by slight rainfall.

- **Drainage management:** Surface runoff from upslope areas flows into the landslide causing erosion and debris flow into settlement. Hence the water from upslope should be drained away from slope using contour trenching, stone dams, catch drains, gabion chutes and/or cross-drainage structures.
- **Retaining structures:** Retaining structures such as gabion walls should be installed on the slope to provide structural support to slope as well as trap debris flowing onto the settlement meanwhile providing porous passage for water to flow. For more structural integrity, reinforced concrete retaining walls with catch aprons or debris traps at their base are preferred.

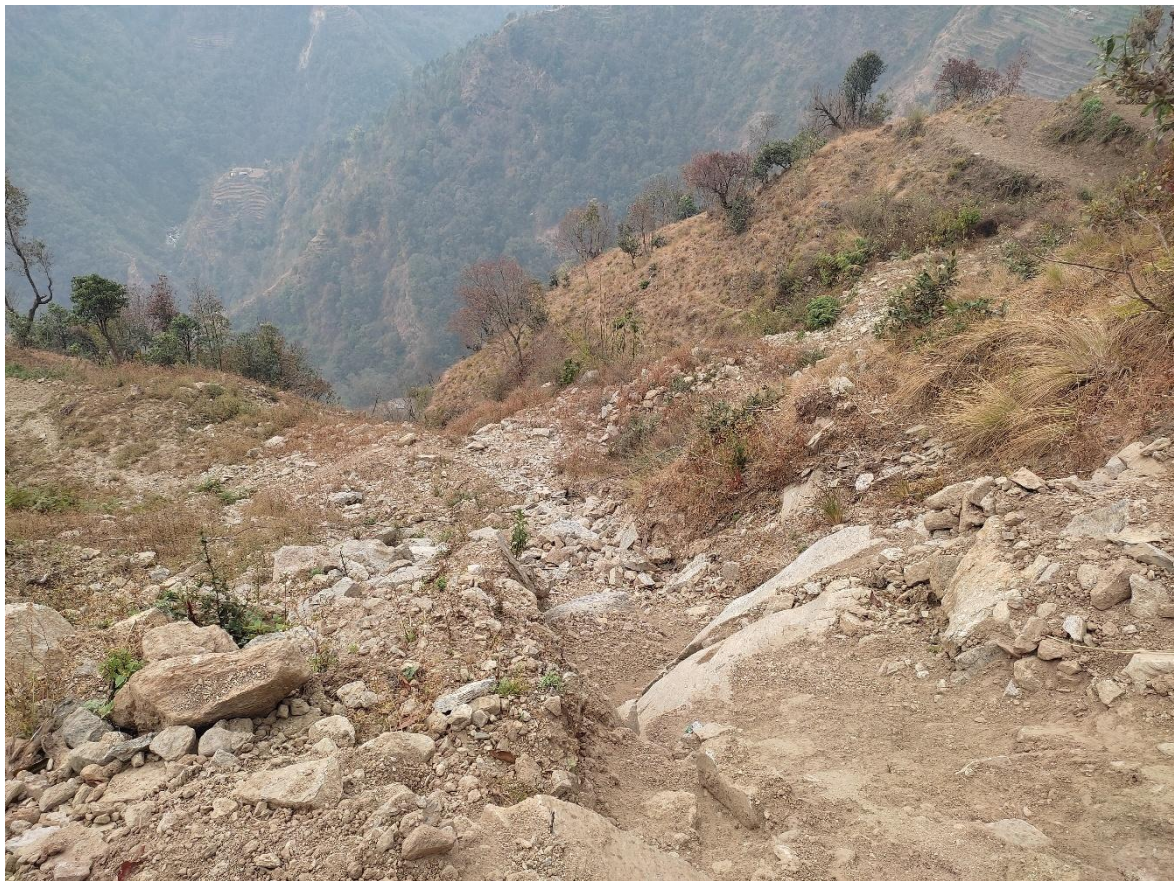
Figure 13: Gully formed by debris flow on the slope

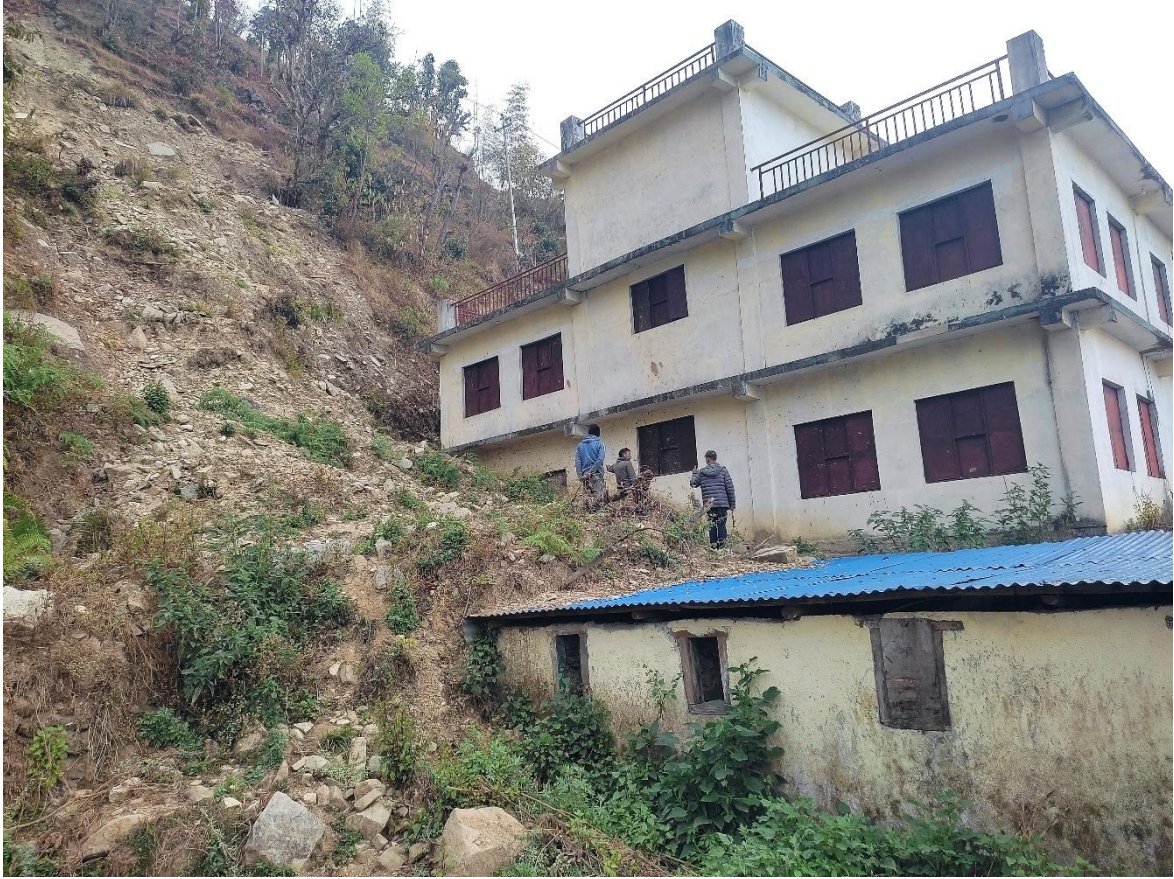
The debris flow from slope has deposited at the back of building constructed for school while toilet of school has been partially covered by debris. The house of Tej Bahadur Sunar was completely destroyed by debris flow, killed his 2 oxen, and agricultural land was covered by debris flow deposits destroying crops. He has relocated away from landslide, while Ambar Bahadur Pahari, whose house was partially destroyed, still resides in the unstable mass. His 2 buffalo were also killed by landslide. Also, the house of Subash Pahari is also at high risk of the debris flow. Cracks can be observed in the house of Ganesh Pahari, structures near his house were destroyed by debris flow. 1 m subsidence can be observed along tension crack ~ 8 m long and 15 cm wide. Another tension crack observed is ~15 m in length and 8 cm wide with depth of 10 cm. Agricultural lands of several locals partially swept away.

Figure 14: Debris flow deposit to the side of building constructed for school and on roof of toilet

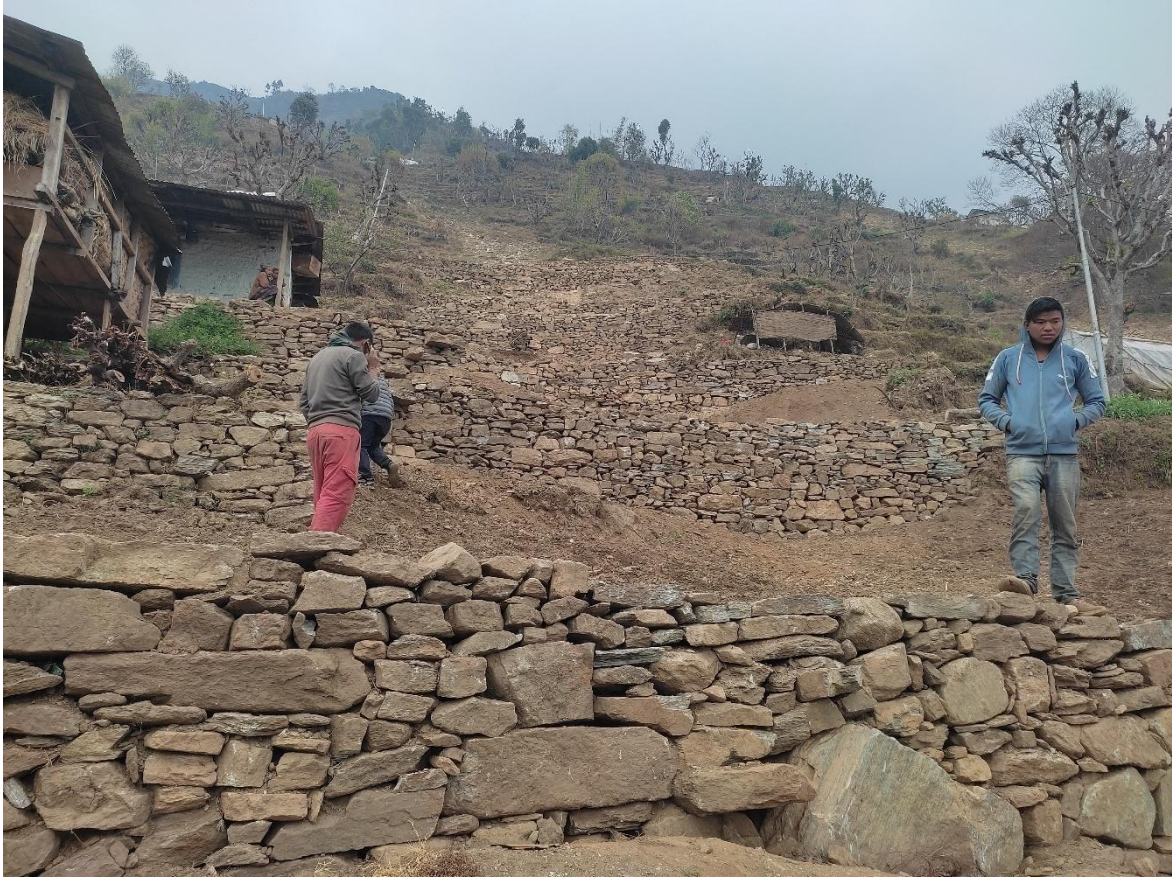
Series of stone stacked wall has been constructed for length ~10 m. This has been constructed locally by effected people at multiple locations.

Figure 15: Dry stone stacked wall constructed by locals to intercept debris flow
